THE IMPORTANCE OF DETAILED FRACTURE ANALYSIS TECHNIQUES TO CORRECTLY EVALUATE BOTTLE BREAKAGE

by
David Machak

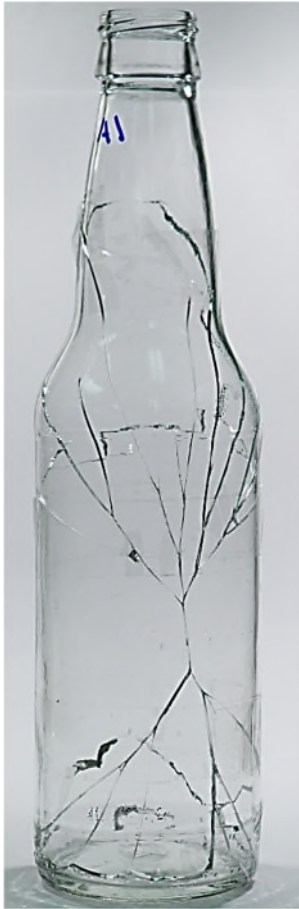
A1
Internal Pressure
Sidewall Origin

Sample A1 is typical of an internal pressure failure with a sidewall origin;
Sample F2 is typical of an impact with an origin at the heel bulb; and
Sample H2 is typical of breakage due to a thermal shock load.

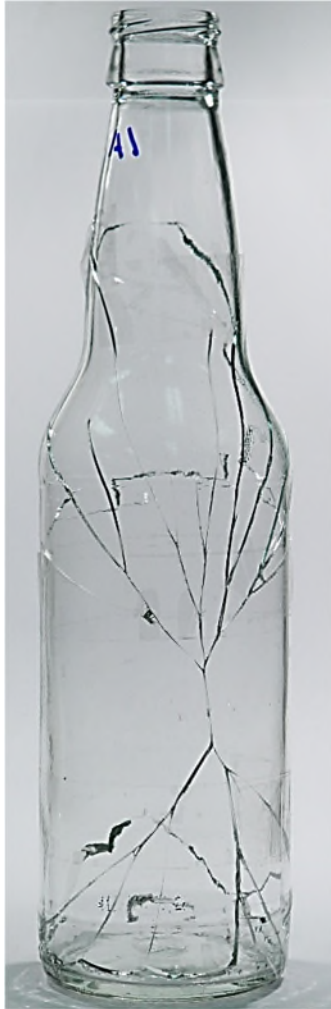
A1
Short Initial Split
High Load Level

Furthermore, the intensity of the fracture pattern can often provide qualitative information concerning the magnitude of the load. In Figure 2 for bottles broken under the action of an internal pressure load with origins in the sidewall, sample A1 has a much shorter vertical fracture and more forking than B1. This shows that the magnitude of the internal pressure was much greater for A1 than for sample B1.

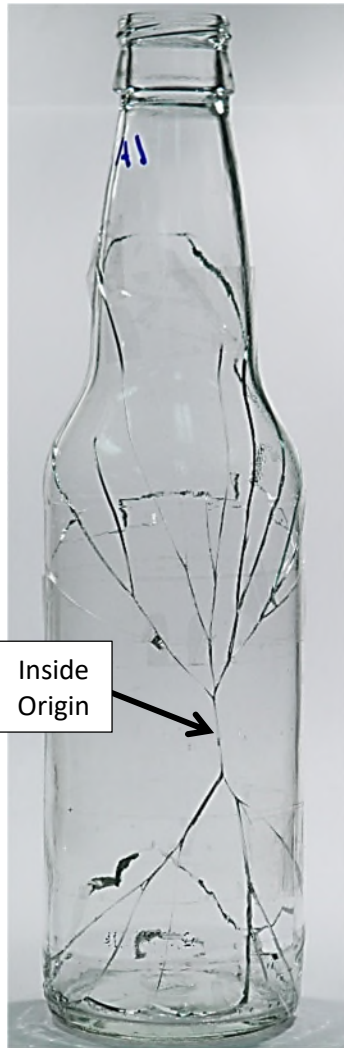
A1
Internal Pressure
Inside Surface Origin

Samples A1 and B5, as shown in Figure 3, exhibit classic internal pressure fracture patterns. It is clear from a cursory understanding of internal pressure breakage, that the fracture origins of both bottles are located between the crack branching in the vertical portion of the sidewall fractures.

Close examination of the markings on the fracture surface reveals important differences. Sample A1 failed at an outside surface fracture origin, while sample B5 failed at an inside surface origin. This information is critical to solving the breakage issue since outside surface flaws can be due to bottle manufacturing conditions or to damage from subsequent handling of the item from bottle manufacturing, through filling, to usage. The sources of inside surface flaws are more commonly related to glass manufacturing issues.

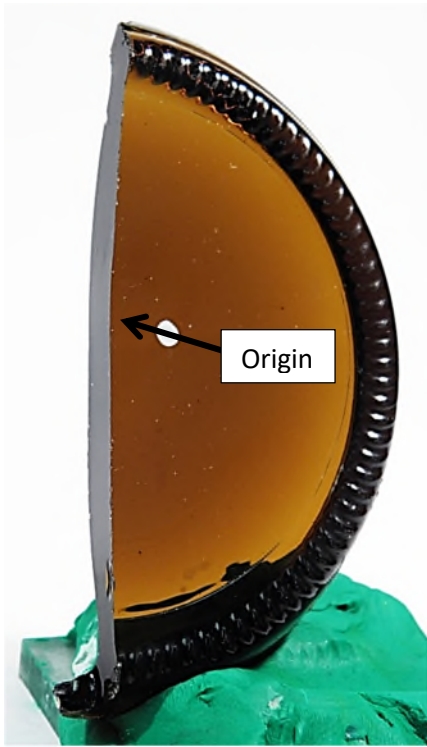
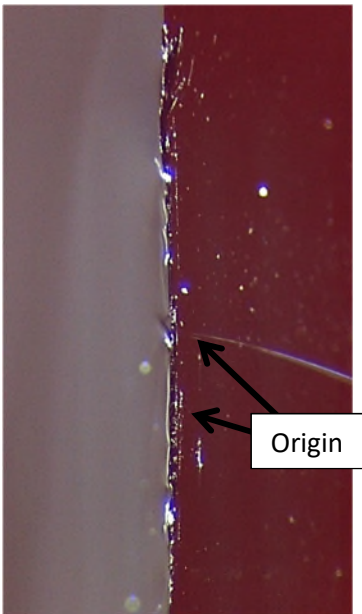
E2 has a fracture origin at damage (scratch) located at the center bottom area;

Thus, while the fracture patterns were identical and caused by the same load (internal pressure), the flaws responsible for the failures were entirely different and unique. Specifically: the flaws at the fracture origins of E4 and E2 were due to abusive, improper handling; while the flaw at the fracture origin of E3 is a glass manufacturing defect.

Bottom Origin
At Scratch

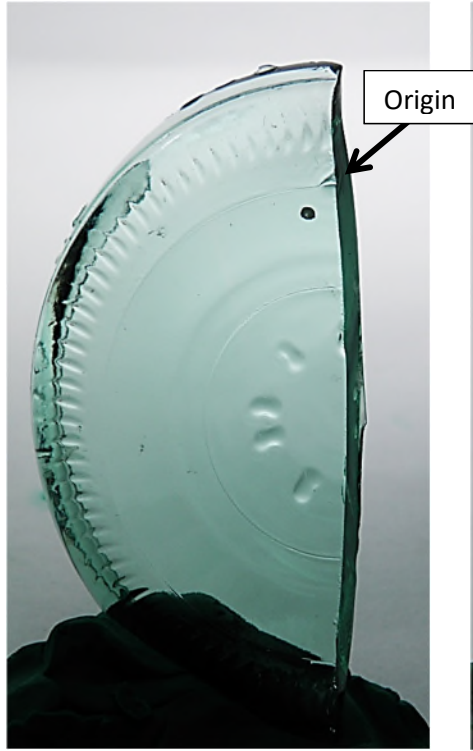
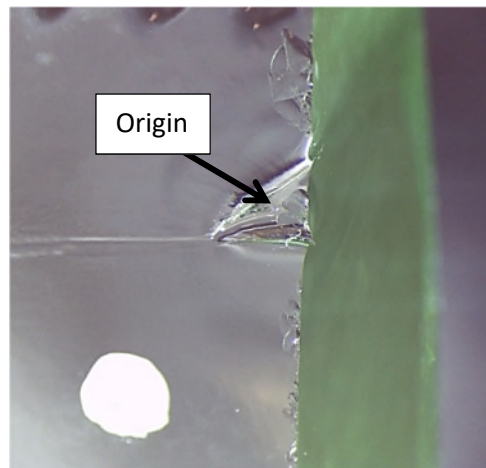
E3 has a fracture origin at a defective baffle/blank seam near the bearing surface; and

Bottom Origin
At Baffle/Blank

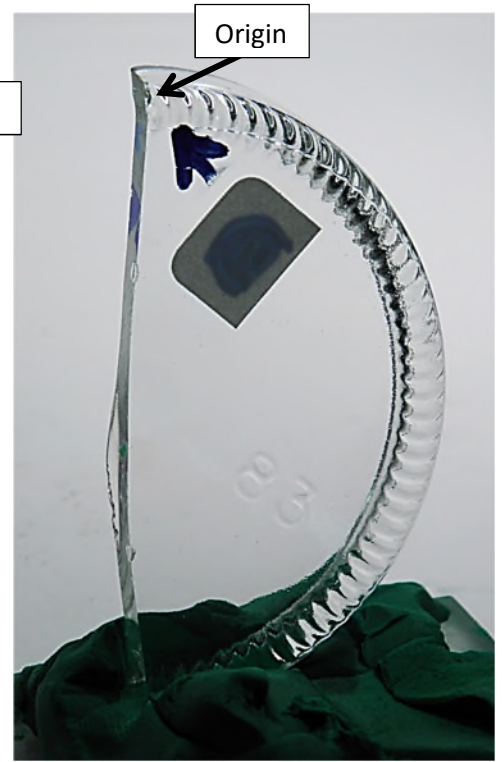
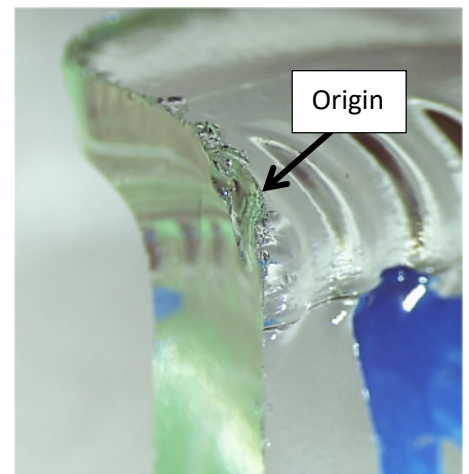
E4 has the fracture origin at a damaged knurl in the bearing surface.

Bearing Surface Origin
At Damaged Knurl

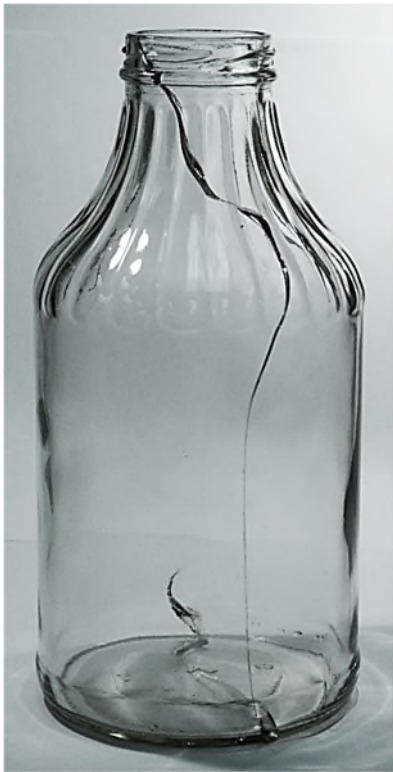
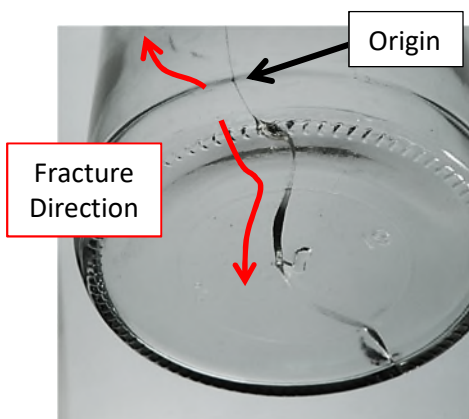
H1
Thermal Shock
Heel Origin

Samples H1 and H2, as shown in Figure 5, both exhibit somewhat similar fracture patterns consisting of a long, vertically aligned crack in the sidewall. While the general fracture patterns indicate that both bottles failed as the result of thermal shock, the fracture origin location and flaw type are not apparent. Detailed fracture analysis established that the fracture on H1 originated at small check in the heel area. The fracture on H2 originated at damage located in the sidewall, that may have been created well after the glass manufacturing operation. The actions that are required to solve these breakage issues are unique and involve correction of a forming defect (H1) and a handling issue (H2).

H1 – Thermal Shock with Heel Origin

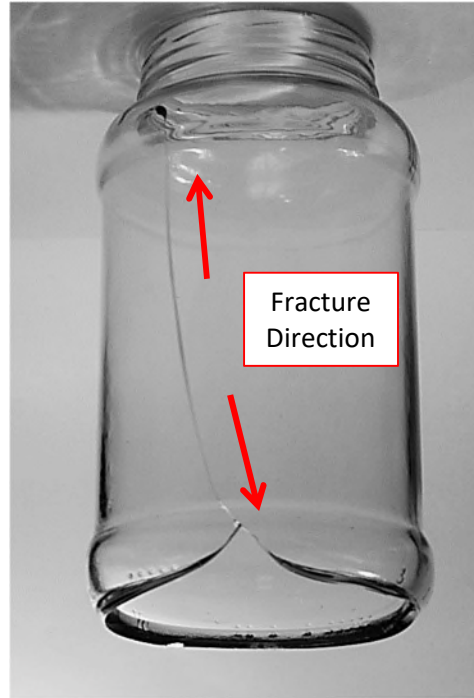
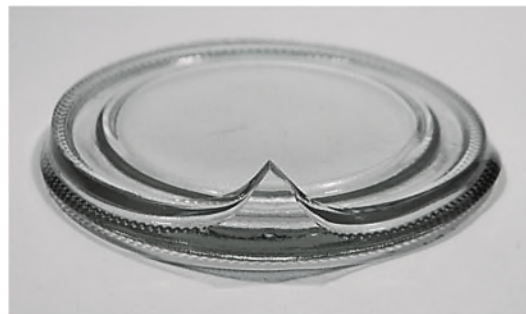
H2
Thermal Shock
Sidewall Origin

H2 – Thermal Shock with Sidewall Origin

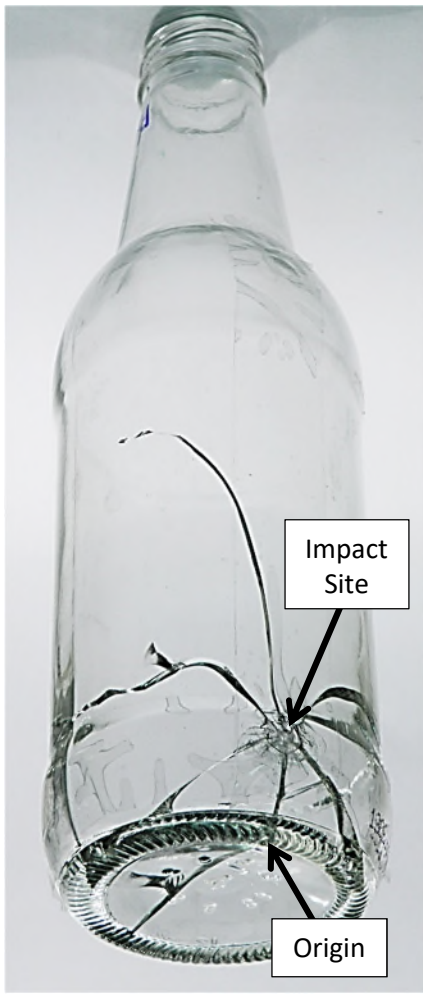
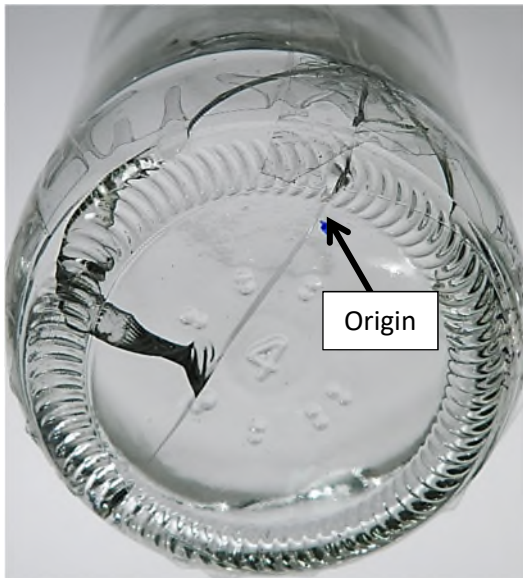
By comparison, sample F1 exhibited a somewhat similar fracture pattern except that there was an additional fracture that radiated across the bottom. The surface markings revealed that the primary fracture originated on the outside glass surface in the bearing surface region. The primary fracture traveled across the bottom and also upward to the impact site. This is commonly termed the “bearing surface hinge” mode of impact failure.

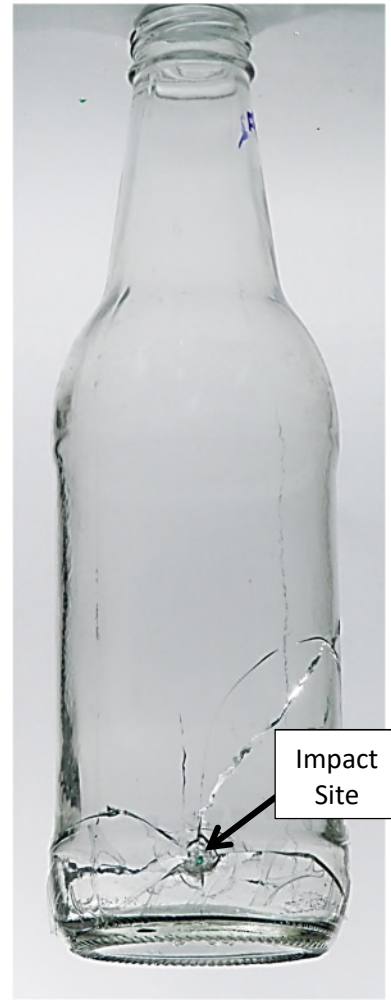
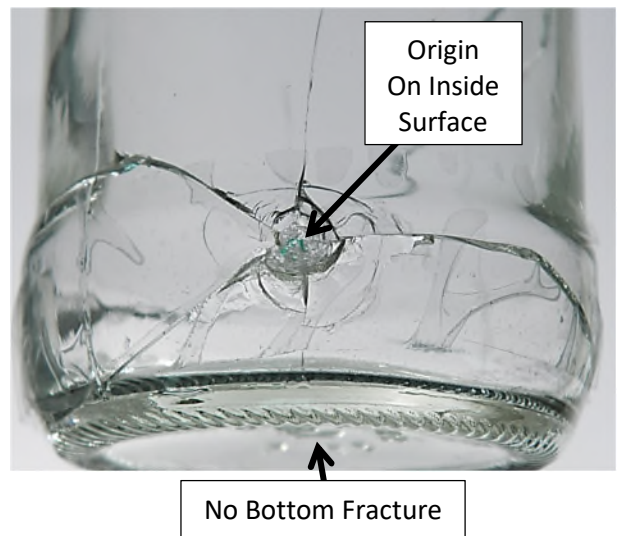
F2 – Flexure at Heel Contact

The fracture surface markings showed that all the fractures on F2 originated on the inside surface opposite the outside surface impact site. This fracture type is referred to as the “flexure” mode of impact failure. The flaw is most likely due to a glass manufacturing related problem that significantly decreased the strength of the inside glass surface.

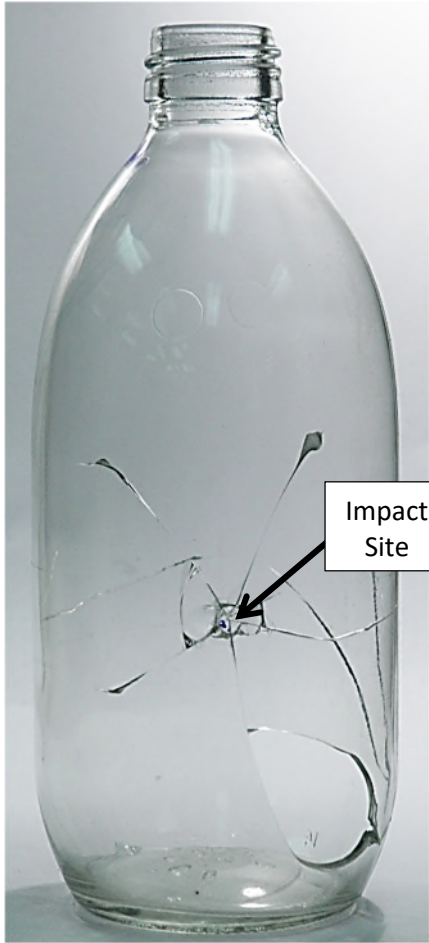
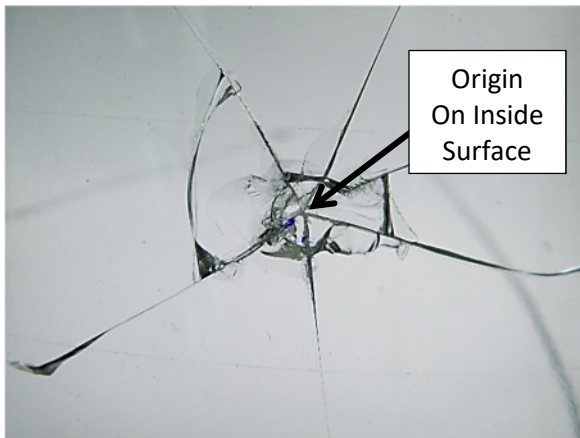
examination revealed that the fracture on F4 originated on the inside surface at the impact site (termed flexure impact breakage as noted previously). Examination of the fracture pattern on sample F3 revealed a second fracture system to the left side of the impact site. The primary fracture originated on the outside surface at this second fracture system. This is referred to as the “sidewall hinge” mode of impact failure. While these two samples exhibited somewhat similar fracture patterns, the two samples broke due to two entirely different failure modes. Additionally, there were different flaw types at the fracture origins, requiring different corrective actions.

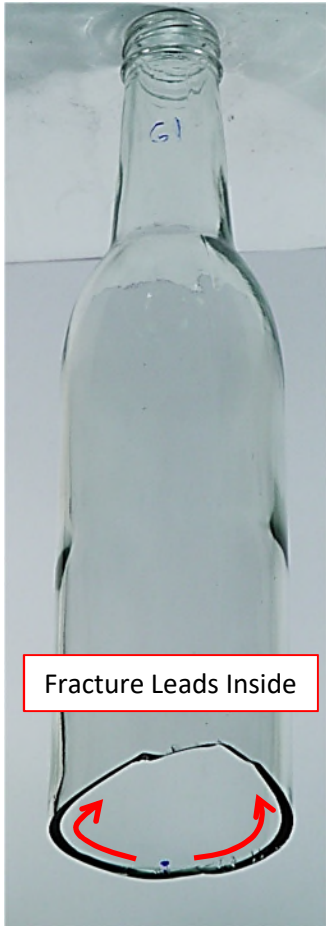
Sample G1 was a bottle which contained a carbonated soft drink. The fracture originated on the inside glass surface at the junction of the sidewall and bottom. This is a classic internal pressure failure with an inside knuckle origin. The primary cause of this failure was a severe flaw that is usually forming related.

G1 – Internal Pressure with Inside Knuckle Origin

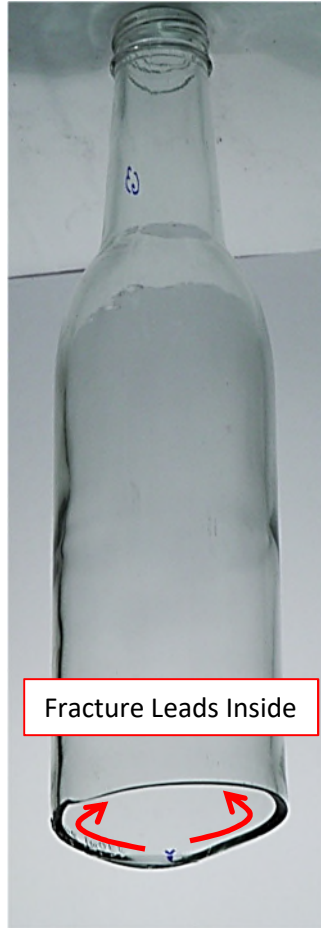
Sample G3 was used for a cold filled, non-carbonated juice product that was pasteurized. This bottle failed as the result of a thermal shock load in which the inside surface was much cooler than the outside surface, a situation referred to as “reverse thermal shock”. The origin was located on the inside surface at a manufacturing flaw.

G3 – Reverse Thermal Shock with Inside Knuckle Origin

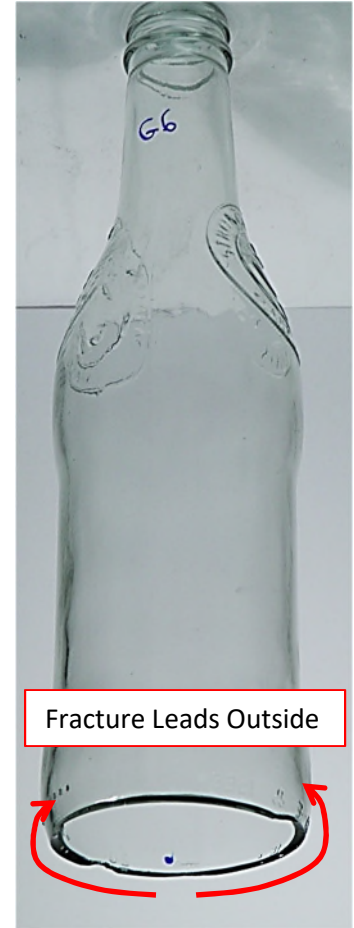
Sample G6 was a bottle which contained a carbonated product. The fracture surface markings were moderately intense and showed that the fracture originated on the outside surface in the heel. The location of the fracture origin was inconsistent with internal pressure as the breaking load, since internal pressure stresses are typically minimal on the outside surface at the heel. Furthermore, this bottle would not typically experience significant thermal shock loads or heel impact loads. Thus, an alternative load must have acted on the bottle at the time of failure.

Detailed fracture analysis indicated that the bottle failed under the action of a force applied to the center portion of the bottom rather than the bearing surface, as normally intended. This force is referred to as a “bottom vertical load”. Due to the unusual application of the force, much higher than expected bending stresses were created on the outside surface of the heel area. The cause of failure was an improperly applied force to the bottom, that most likely occurred during capping.

G6 – Bottom Vertical Load with Heel Origin

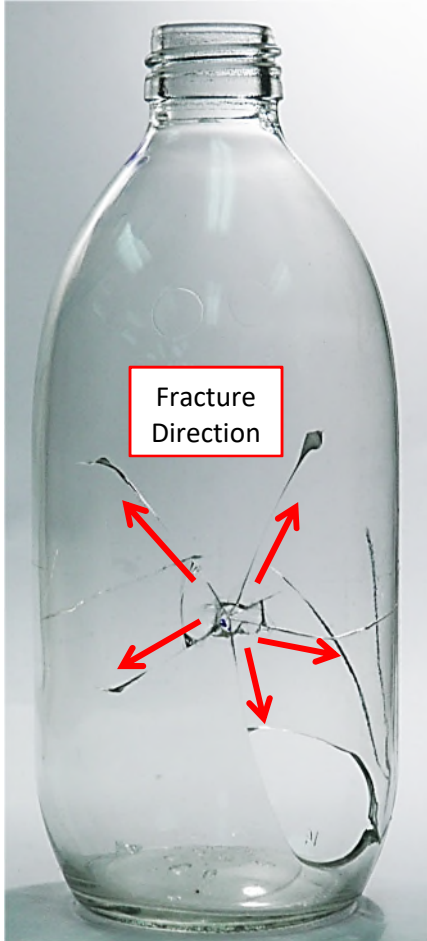
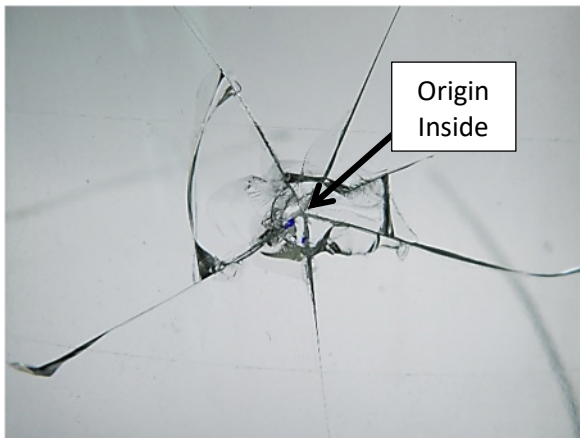
Sample F4 exhibited a number of cracks originating from a single point on the inside surface underneath the impact site. This is the “flexure” mode of impact failure having an inside origin, as previously discussed. The corrective actions would be to identify and eliminate the inside surface flaws.

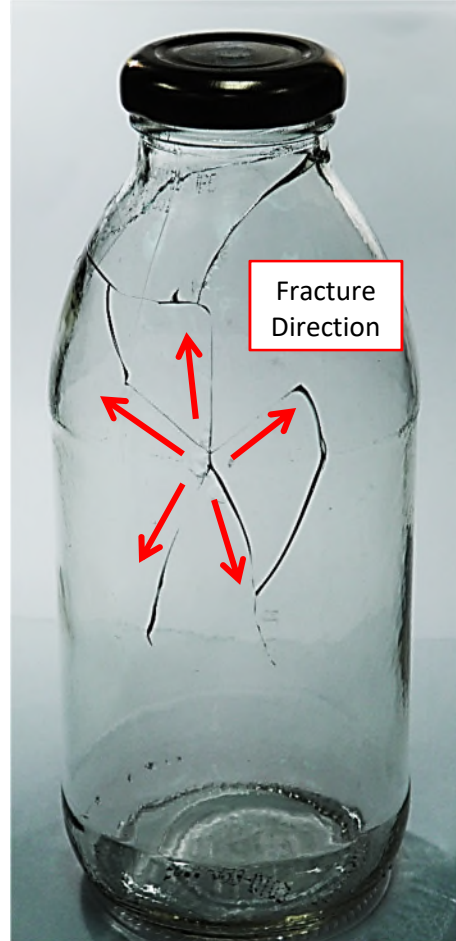
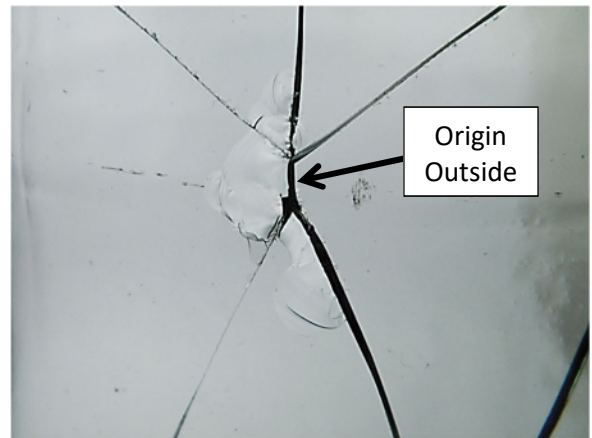
Close examination of sample I2 showed that the fractures originated on the outside surface at the center of the fracturing. The fracture pattern and forking generally resembled a flexure impact failure, but from an impact to the inside surface with a flaw on the outside. This is a type of “hydrodynamic” breakage resulting from inappropriate rough handling of a filled, vacuum packed product. The handling problem caused a bubble to form within the liquid product which then collapsed on the inside surface, creating a tensile stress on the outside surface. The analysis showed that the flaw was not excessively severe. This information showed that the magnitude of the applied load was excessive and the primary cause of failure. The corrective action would be improved handling.
