## Case Study #2: Breakage of Nail Polish Bottles

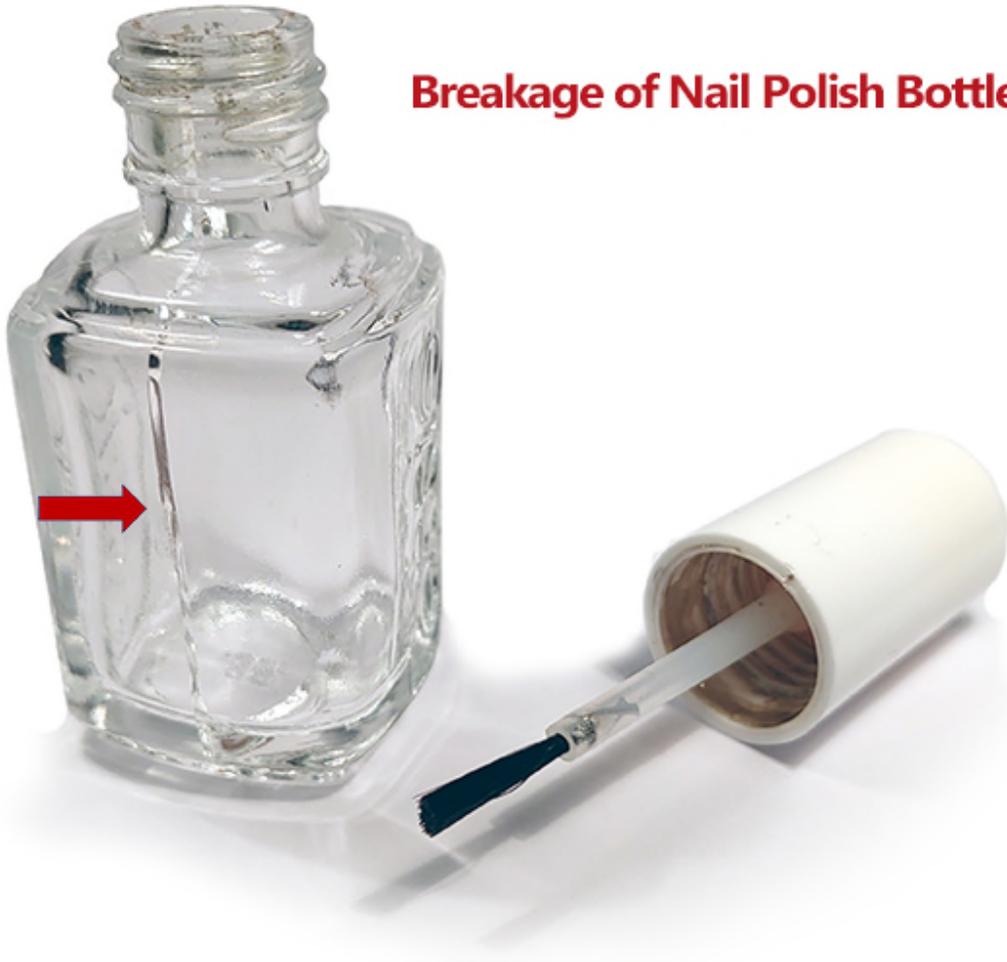
## Breakage of Nail Polish Bottles

The fracture origins were consistently located in the mid-point of the upper sidewall of the bottles as shown by the example in Figure 1. Based on the physical dimensions of the mirrors that were present on the fracture surfaces, the average breaking stress was 5780 psi (405 kg<sub>f</sub>/cm<sup>2</sup>). Since glass strength is defined as the magnitude of the tensile stress at failure, this stress value represents the glass surface strength at the fracture origin site. Consulting a standard strength table, it was concluded that the glass strength was acceptable for a long-time load duration. Therefore, it was necessary to focus on the factors that led to the creation of an elevated level of tensile stress.

hydraulic force on the inside surface of the container. As the pressure increases, the flat panels of the container bend outward creating a high tensile stress on the outside glass surface in the sidewall region of the containers. This would account for the presence of elevated tensile stresses and for fracture origins to be consistently located in the mid-point of the upper sidewall region.

Two factors have the potential to create a hydraulic internal pressure load. The first is the overflow capacity of the containers and the second is the total volume of the liquid product. The overflow capacity of representative unbroken containers ranged from 20.2 ml to 20.9 ml which met the blueprint specification of  $20 \text{ ml} \pm 1.5 \text{ ml}$ . The measured liquid volume ranged from 17.8 ml to 18.3 ml which exceeded the targeted volume of 16.0 ml to 17.5 ml.

Thus, the cause of the hydraulic pressure was an excessive liquid volume when the containers were filled. The total overflow volume of the cosmetic container must be designed to account for the product volume, the headspace volume, any mixing balls that might be present as well as the volume of the polish applicator. Failure to account for all of these "product" volumes will potentially result in hydraulic pressure situations.
