Identifying breakage issues in crown closure bottles

Dr. Clarissa L. Justino de Lima and Peter W. de Haan report on findings obtained from using a medical CT scan in a novel manner to investigate how guide ring seam irregularities can result in breakage issues for both pry-off and twist-off finish bottles.

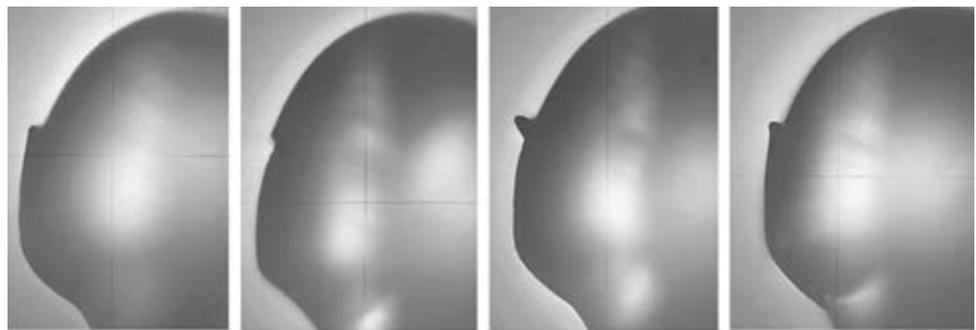
Common finish irregularities associated with the guide ring seam and neck rings [of crown closure glass bottles] are categorised as undermatch, overmatch, flange, or knockout. Examples of these four types of irregularities are shown in Figure 1. As shown in these cross-sectional views, a knockout has a similar physical appearance to a flange. However, a knockout is restricted to the junction of the vertical neck ring seam with the horizontal guide ring seam whereas a flange can occur at any position along the guide ring seam and typically extends around the circumference of the finish for some distance.

Overmatch and undermatch features are predominantly caused by misalignments or dimensional issues between the neck ring components of a finish mould. Flanges and knockouts are usually caused by improperly closed neck ring halves or damaged and/or misaligned mould parts. Flanges, overmatches and knockouts are normally regarded as more serious problems as they are susceptible to breakage upon

Figure 1: Guide ring seam irregularities.

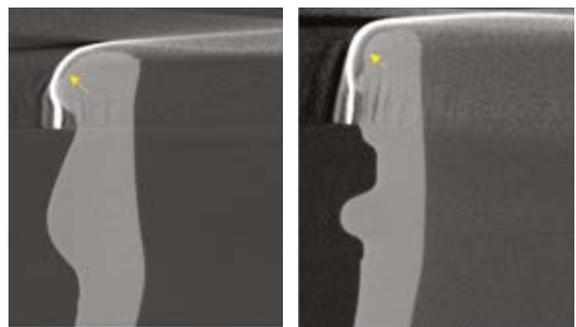
Figure 3: Examples of distances between the finish and the closure.

The average total distance between the guide ring seam and the closure for pry-off and twist-off finishes were 0.39mm and 0.53mm, respectively, a statistically significant difference at a confidence level of 95%. As shown in Figure 3, these differences are due to the configuration of these two types of finishes and the manner in which the closure interacts with the finish. The presence of threads combined with a right angle between the finish E wall and the sealing surface of twist-off finishes results in a relatively large distance between the finish and the closure skirt. The obtuse angle between the crimp bead and the sealing surface of a pry-off finish led to a relatively small distance between the finish and the closure skirt.

As a consequence, finish irregularities of the same dimension would be more concerning when located on a pry-off bottle as they would be located closer to the closure, which increases the risk of becoming damaged during the crowning operation. For example, the maximum irregularity height for the pry-off bottles was 0.29mm which was the same as the minimum 'total distance' (0.29mm). For twist-off finishes, the minimum 'total distance' was 0.45mm, which would provide ample space to accommodate the largest irregularity height measured in this study.

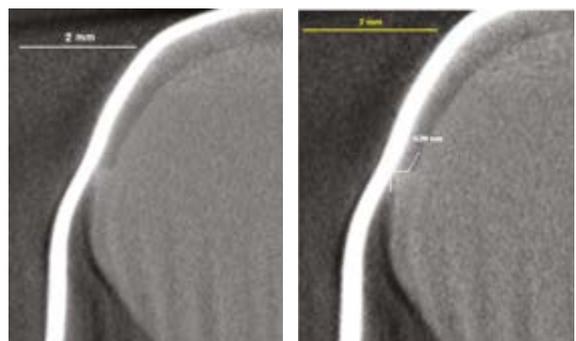
Figure 4: Undermatch with no space between the guide ring seam and the closure.

Figure 4 shows an unusual situation in which an undermatch can also act as a focal point of contact stresses leading to breakage under abnormal situations. In this example, the edge of the undermatch feature is in direct contact with the closure and high contact stresses will be generated. These stresses could lead to the development of a cone crack and ultimately the potential for complete failure of the finish.

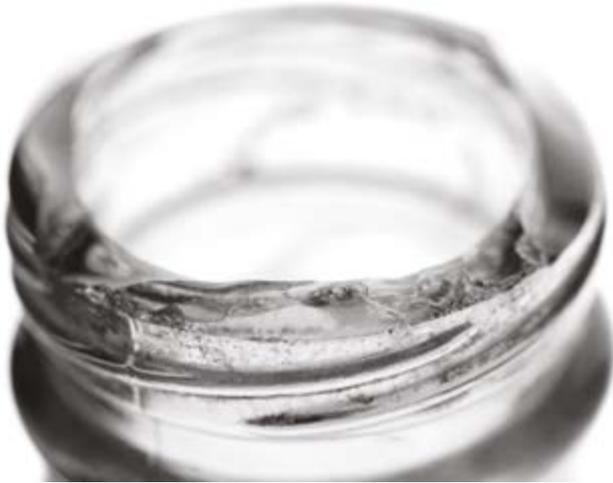
Figure 5: Representative fracture pattern.

#1: Twist-off closure: A beverage filler received a series of consumer complaints regarding fractures of twist-off finishes as shown in Figure 5. The fractures originated at percussion cones which coincided with an overmatch of the outer guide ring seam (0.26mm), as shown in Figure 6. The overmatch acted as a focal point for the crimp forces during application of the crown closure leading to the formation of a cone crack. Extension of the cone crack into a complete failure occurred by either a leverage force generated by the use of a bottle opener or a shear force from the twisting motion of the closure. In either case, the overmatch was the cause of the problem.

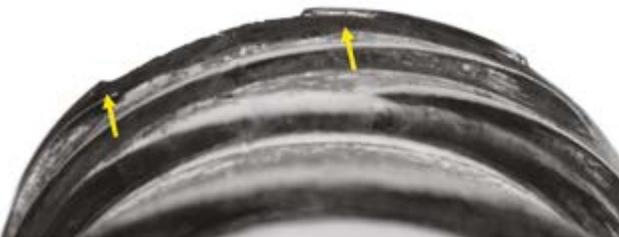
Figure 6: Overmatch defect measuring 0.26mm.

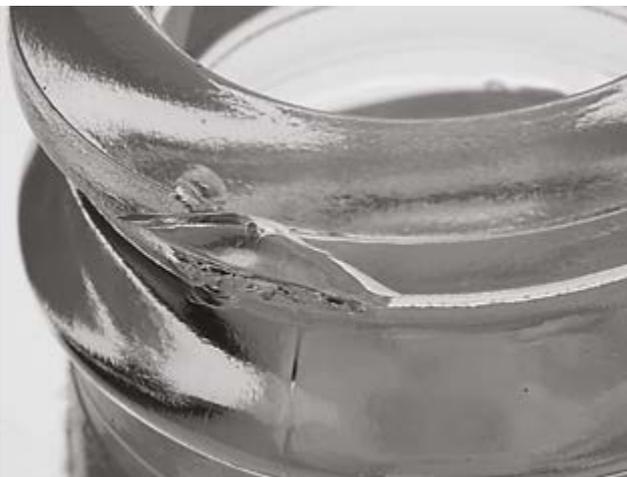
Figure 7: Percussion cone.

#2: Pry-off closure: A beverage company received a consumer complaint related to a fractured finish as shown in Figure 7. The fracture initiated at the outer-guide ring seam, which exhibited a flange (0.12mm), as shown in Figure 8. The force applied to the flange during closure application created high contact stresses in the glass which resulted in chippage of the finish.

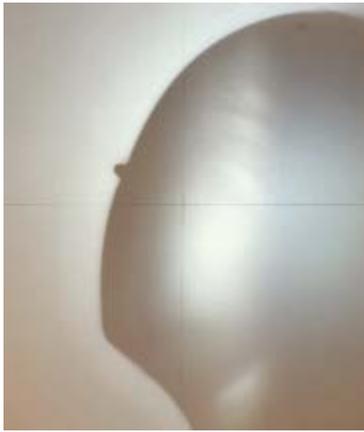
Figure 8: Flange measuring 0.12mm.

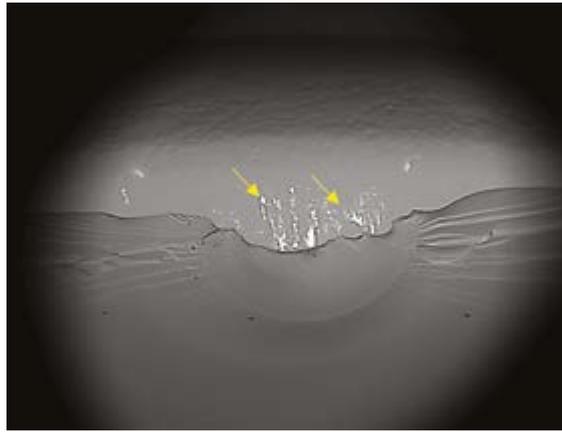
Figure 9: Metal to glass frictive damage.

#3: Bottle opener: A filler received a consumer complaint related to the fractured finish of a beer bottle that originated at a cone crack. Metal-to-glass damage was also detected at the fracture origin, as shown in Figure 9. Analysis of the metal composition indicated that it was

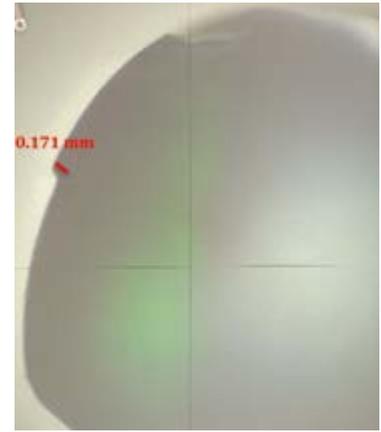
Figure 10: Overmatch measuring 0.17mm.

deposited from a device used to remove the closure. Furthermore, the bottle exhibited an overmatch (0.17mm), as shown in Figure 10. High contact stresses were generated upon contact of the overmatch during closure removal which caused the breakage.
