Case Study #3: Pasteurizer Breakage

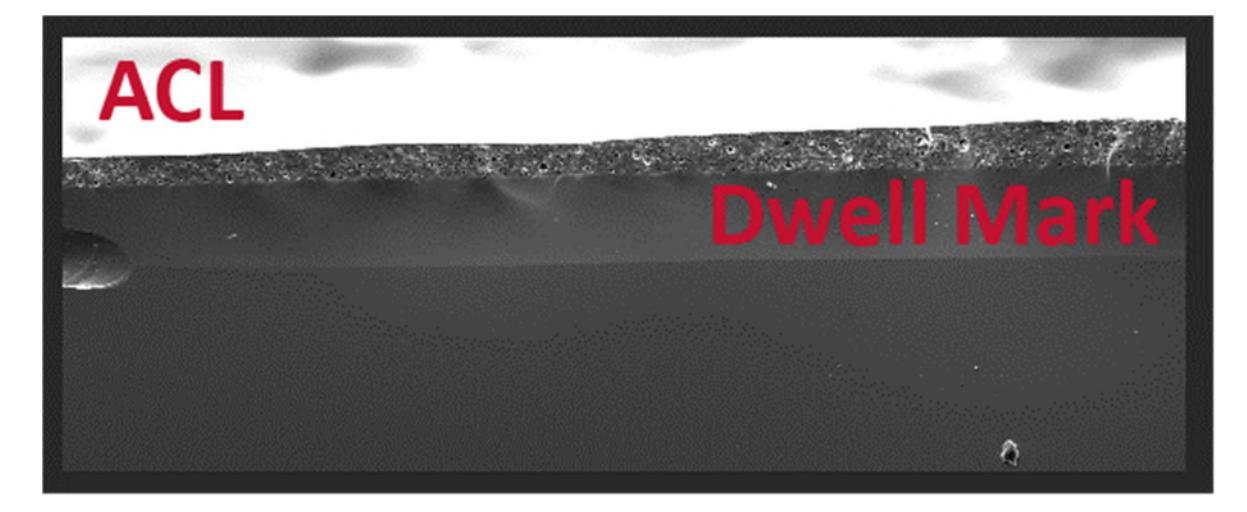
Figure 1

Based on the nature and simplicity of the fracture pattern, it was concluded that the bottles failed under the influence of a very low-level internal pressure. The absence of any mirrors at the fracture origins indicated that the failures occurred at very low stress magnitudes. Thus, the breakage was associated with inadequate glass surface strength.

Microscopic analyses indicated that shallow dwell marks were present on the fractured surfaces as shown in Figure 1. These dwell marks had been generated from numerous micro-cracks that were observed at the ACL-glass interface as shown in Figure 2. Thus, the source of the abnormally low glass strength was due to the presence of the micro-cracks that had extended from the ACL into the glass surface.

Dwell Mark at the ACL-Glass Interface

Thus, the cause of the breakage was due to a mis-match of the coefficient of thermal expansion (CTE) between the ACL and the glass substrate. In order to avoid this situation, it is necessary to assure that the CTE of the ACL and glass are equal or nearly equal in magnitude.

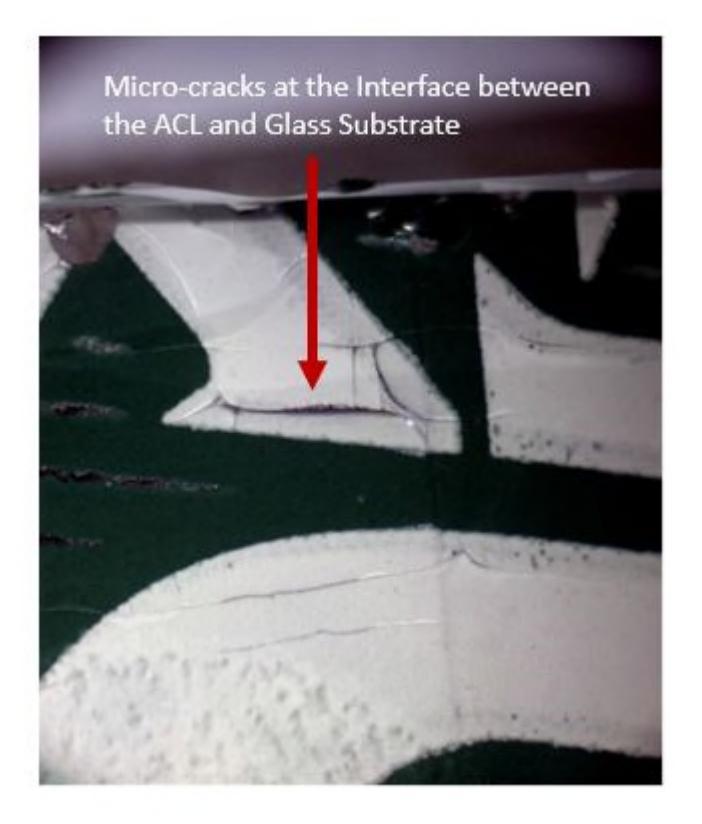
Figure 2

Analysis of ring sections cut from the vicinity of the fracture origins indicated that compressive stresses as high as -1113 psi (-77.9 kg_f/cm²) were present in the glass immediately beneath the ACL. It can be inferred that tensile stresses of

greater magnitudes would have been present in the ACL. Tensile stresses of such high magnitudes usually result in the creation of micro-cracks in the ACL as observed in this situation.

Micro-cracks at the Interface between

the ACL and Glass Substrate
