## **Failure of Glass Tubing Vials during Lyophilization**

*PDA J Pharm Sci and Tech* **2019**, 73 30-38

DAVID R. MACHAK\* and GARY L. SMAY

*American Glass Research, a Division of AGR International, Inc., 603 Evans City Road, Butler, PA, USA. ©PDA, Inc. 2019*

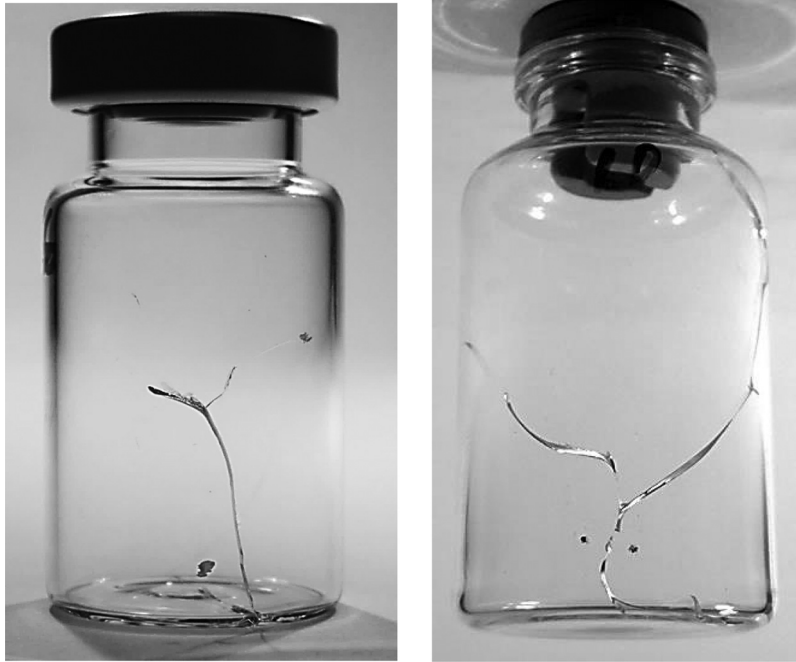
**Figure 1**

**Lyo-breakage: typical fracture patterns from commercial practice.**

tubing vials, which, in our experience with fracture diagnosis of vial breakage during lyophilization, manifests in a majority of instances by the fracture pattern shown in Figure 1. This pattern is characterized by a vertical fracture in the lower sidewall region sometimes with forking above and/or below the origin site, which occurs on the outside glass surface.

Based on the fracture diagnosis techniques summarized in the published literature (5–8) and as shown by the examples in Figures 2 and 3, it was concluded that the fracture patterns shown in Figure 1 are uniquely characteristic of breakage caused by a force applied to the inside surface of a vial causing it to expand outward. To confirm this conclusion, a finite element computer stress analysis (FEA) of a tubing vial that had been produced under normal commercial operations was undertaken. The profile and glass thickness distribution of the vial used in these analyses is shown in Figure 4. In these analyses, a 3D symmetrical model was created using Solidworks, and the model was then imported into Autodesk® Simulation for the purpose of performing the FEA. The horizontal force simulated the expansion of water when it freezes into ice. The results of the FEA in Figure 5 show that the outward expanding force generates tensile stresses of nearly equal magnitude on both the inside and outside glass

Even with this information, it is necessary to consider the assertion that lyo-breakage is caused by stresses generated by temperature gradients that are assumed to be created during the lyophilization process. If a thermal gradient were the major factor that caused lyo-breakage, the fracture pattern would consist of meandering cracks in the sidewall and bottom regions with origins that would most likely be located on the outside glass surface in the bottom or heel areas as discussed in the literature (5,7,8) and as shown in Figure 3. This is in direct contrast to the fracture pattern that is observed for vials that break during commercial operations as shown in Figure 1.

The breakage pattern shown in Figure 7 consisted of a single vertical sidewall fracture with a fracture origin on the outside glass surface in the lower sidewall area consistent with the superposition of tensile stress created by the expanding ice with the surface damage created by the emery paper abrasion. This fracture pattern was identical to the pattern that is typically observed on the most common type of breakage that occurs during lyophilization as shown in Figure 1.

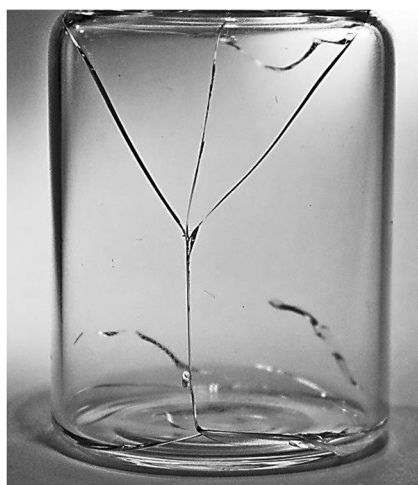
a) Failure at relatively high pressure

**Examples of vials that failed due to an internal pressure force.**

Examples of different crack patterns of broken glass vials are shown in Figures 2 and 3. The vials in Figure 2 were broken by an internal pressure force that was created by filling the vials to overflowing with water and subjecting the filled vials to hydraulic pressure. The pressure was initially low and was increased until the vial failed. The fracture pattern consisted of a vertical crack that could exhibit branching above and below the precise location where the fracture originated. The vial in Figure 2A exhibited extensive frac-

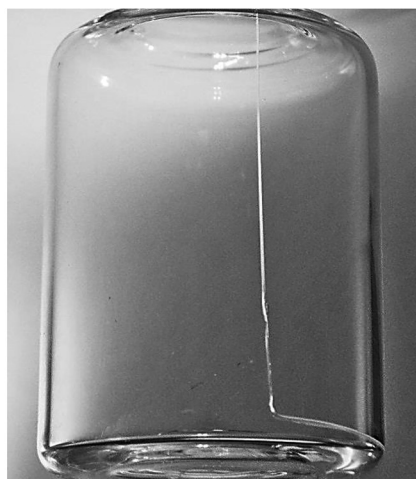
b) Failure at relatively low pressure

turing, which is typical of relatively high pressures. The vial in Figure 2B failed at a much lower pressure and exhibited a relatively simple pattern consisting of only a straight vertical crack with looping in the lower end.
