THE IMPORTANCE OF DETAILED FRACTURE ANALYSIS TECHNIQUES TO CORRECTLY EVALUATE BOTTLE BREAKAGE

by
David Machak

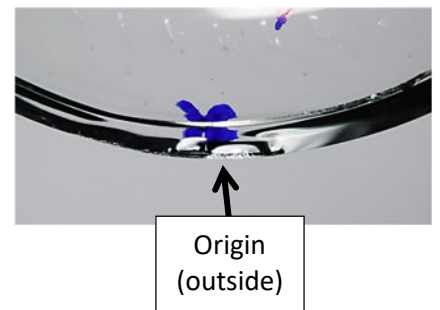
FIGURE 9
Similar Fracture Patterns with Different Breakage Modes
F4 – Flexure with Inside Origin
I2 – Hydrodynamic with Outside Origin

As shown in Figure 9, samples F4 and I2 exhibit somewhat similar fracture patterns. This similarity could mistakenly indicate a common cause of failure. However, detailed fracture analysis indicated otherwise.

Sample F4 exhibited a number of cracks originating from a single point on the inside surface underneath the impact site. This is the “flexure” mode of impact failure having an inside origin, as previously discussed. The corrective actions would be to identify and eliminate the inside surface flaws.

Close examination of sample I2 showed that the fractures originated on the outside surface at the center of the fracturing. The fracture pattern and forking generally resembled a flexure impact failure, but from an impact to the inside surface with a flaw on the outside. This is a type of “hydrodynamic” breakage resulting from inappropriate rough handling of a filled, vacuum packed product. The handling problem caused a bubble to form within the liquid product which then collapsed on the inside surface, creating a tensile stress on the outside surface. The analysis showed that the flaw was not excessively severe. This information showed that the magnitude of the applied load was excessive and the primary cause of failure. The corrective action would be improved handling.
