Identifying breakage issues in crown closure bottles

Dr. Clarissa L. Justino de Lima and Peter W. de Haan report on findings obtained from using a medical CT scan in a novel manner to investigate how guide ring seam irregularities can result in breakage issues for both pry-off and twist-off finish bottles.

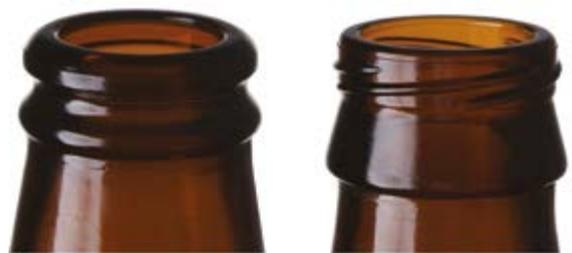
Figure 2: Different finish types.

The samples used in this study consisted of empty 330ml and 600 ml bottles with a pry-off finish and 250 ml bottles with a twist-off finish; these latter bottles had been previously filled and capped in a commercial filling line (the finish types are shown in Figure 2). The empty bottles were manually capped with crimp values that are typical for these types of finishes.
